St Finians School

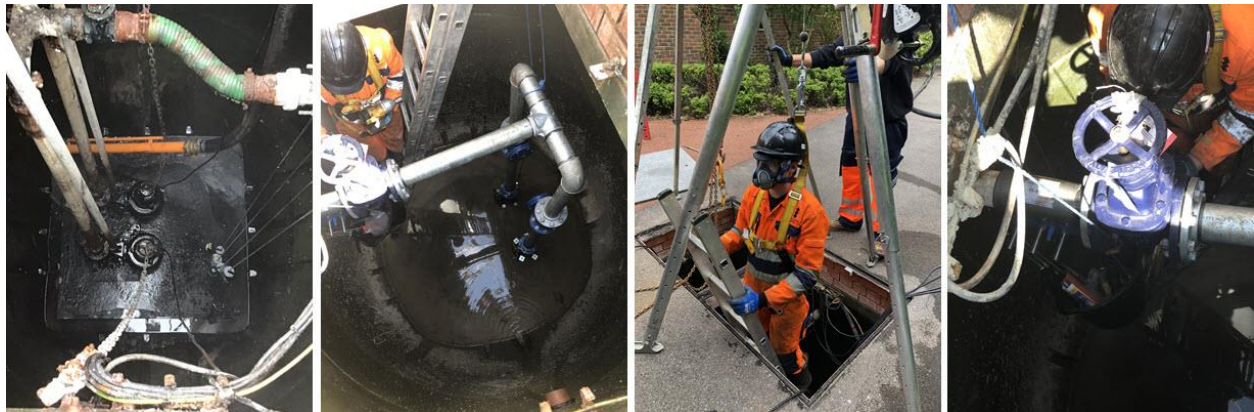
This was a big project; the bottom of the tank had burst due to poor concrete grade eroding over the years.

- We cut out the bottom of the tank, where you can see a fix had been attempted with a metal plate.
- Removed the tank bottom, and failed pipework.
- New concrete with steel mesh.
- New pedestals and pipework, made to measure with our cutting and threading tool.
- Complete to existing discharge.
- Reused floats, panel and pumps.
