St Finian's School

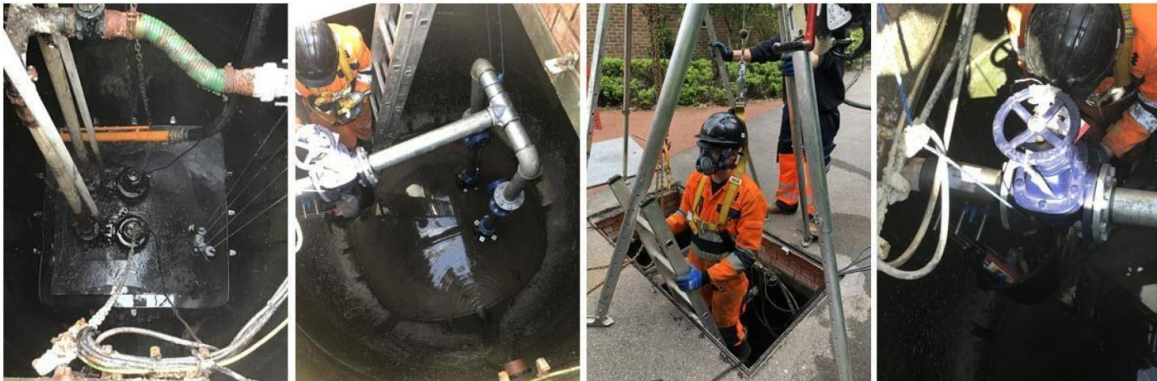
This was a big project; the bottom of the tank had burst due to poor concrete grade eroding over the years.

- We cut out the bottom of the tank, where you can see a fix had been attempted with a metal plate.
- Removed the tank bottom, and failed pipework.
- New concrete with steel mesh.
- New pedestals and pipework, made to measure with our cutting and threading tool.
- Complete to existing discharge.
- Reused floats, panel and pumps.
