# **Charlbury Community Centre, Oxford**

## The Problem:

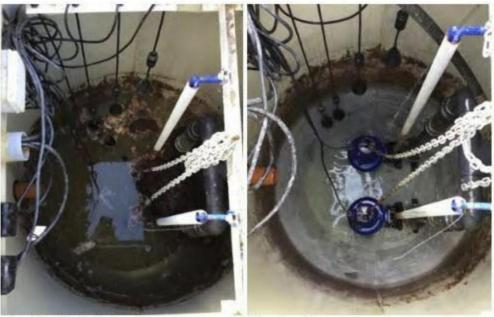
They surveyed the site and discovered that the blockage was mostly paper towels, but some Fats Oils and Grease and human waste. Also, the chambers had some debris inside which was causing additional problems.

- Chamber 1 had a Non-Return Valve stuck open. It also required cleaning and servicing.
- Chamber 2 worked within normal parameters, but required cleaning and servicing.

One of the blocked chambers

Chamber after service, vacuuming and jetting

Our engineers, Alan and Sam Werrell, cleaned the tanks completely, removed the pumps to clean and service them, then re-installed them. They also fixed the problem with the NonReturn Valve which was caused by a stone obstructing the flap.

The entire system was vacuumed and jet cleaned, Tank lids were replaced and correctly sealed and then everything, including all of the control systems, was put through a thorough test programme.
